Manhole Inspection Summary

Manhole # S43G2_004MH

Location Address: **4301 West Bay Ave**

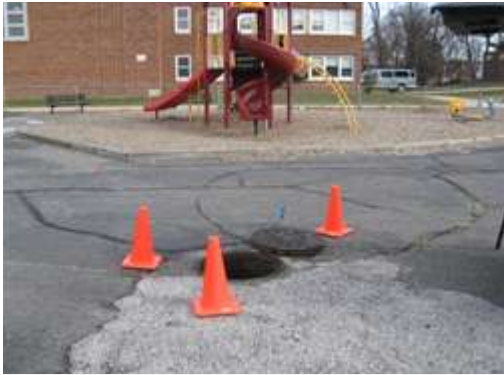
Location View

West Bay Ave. (Curtis Bay Elementary)

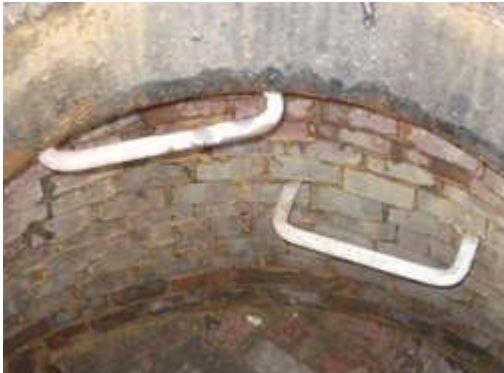
Steps

Count: **2** Missing: **0** ☐ Corroded

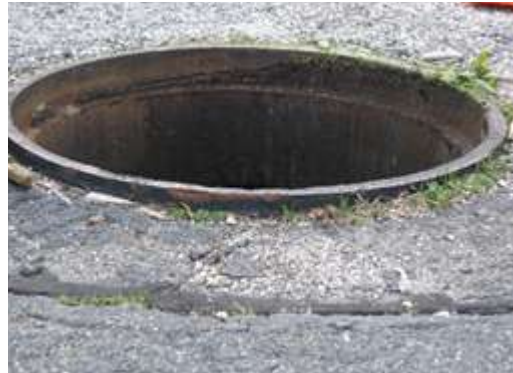
Defect 1

Above grade

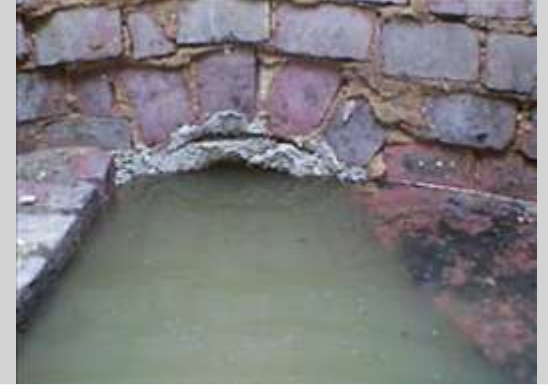
12 O'Clock Outflow

8 in. Circular Gravity Sewer
Pipe Out @ 12 O'Clock

Pipe Height: **9.6** (in.) Rod and Bar (Angled)
Pipe Material: **Clay** ☐ Pipe Lined
Invert Depth: **4.45** (ft.) Flow Characteristics: **Slow**
Deposits: ☒ None ☐ Mud ☐ Sludge ☐ Debris ☐ Grease
Silt Depth: (in.) Deposits Extent:
Infiltration: **None** Pipe Seal Cond: **Cracked**

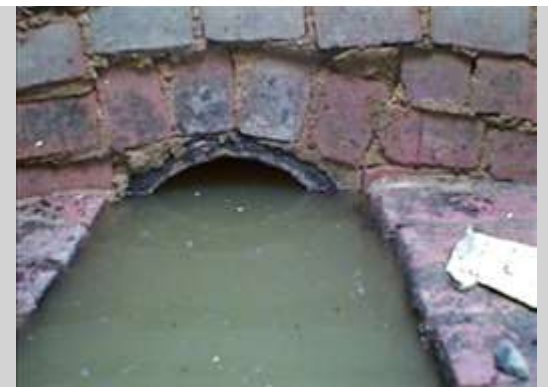
4 O'Clock Inflow

8 in. Circular Gravity Sewer
Pipe In @ 4 O'Clock

Pipe Height: **8.4** (in.) Rod and Bar (Angled)
Pipe Material: **Clay** ☐ Pipe Lined
Invert Depth: **4.32** (ft.) Flow Characteristics: **Slow**
Deposits: ☒ None ☐ Mud ☐ Sludge ☐ Debris ☐ Grease
Silt Depth: (in.) Deposits Extent:
Infiltration: **None** Pipe Seal Cond: **Sound**

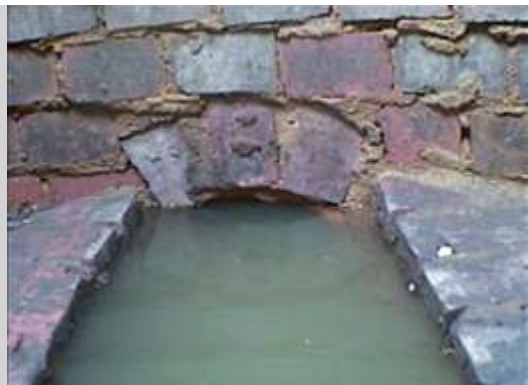
7 O'Clock Inflow

8 in. Circular Gravity Sewer
Pipe In @ 7 O'Clock

Pipe Seal Cond: **Sound**

Connects To: **House connection / Service line**
